Customer	BOSTON MANOR LUL STATION (ABM)	Resource	[redacted]
Contact	ABM Pest Helpdesk	Assisted by	[redacted]
Address	Brentford TW8 9LQ	Job type	ABM - LUL Pest Control - Fault
		Reference	PC/ABM/F/01178
		Order number	56177809
		Date	19/07/2024 01:00 - 04:00
Billing address	ABM UK World Business Centre 3, Newall Road London Heathrow Airport Hounslow TW6 2TA	Job duration	03:00:00
		Driving duration	00:46:22
		Distance travelled	0 mi

Notes: EB platform canopy - Pigeon netting - pigeons are managing to get through the netting and causing a mess on the platform

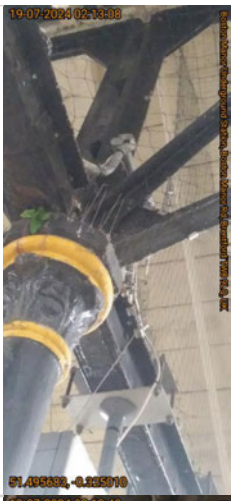
Photo 1

Pest Species Active	Feral pigeon (Columba livia)
Location	External
Level of Activity	Medium
Work Report:	On full inspection. Found some holes by the middle Pillar in the platform. Found 4 pigeons in netting. Found pigeon guano on VID Installed spike in the holes by the pillars.(All the pillars proofed) Culled 4 pigeons, bagged and properly disposed. Cleaned all the pigeon guano on VID and also disinfected the affected area with virusolve. Tidy up our area before signing out with Supervisor.
Recommendations (Environmental/ Housekeeping/ Hygiene)	None
Recommendations (Fabric/ Proofing/ Structural)	None
Recommendations (Other)	None
Product Used:	Fix All Crystal
Quantity (g)/(ml):	300
Product Used (1):	Other
Other (1)	Virusolve
Quantity (g)/(ml) (1):	5
