Customer	EDGWARE ROAD (H&C) LUL STATION (ABM)	Resource	[redacted]
Contact	ABM Pest Helpdesk	Assisted by	[redacted]
Address	Cabbell Street London NW1 5DH	Job type	ABM - LUL Pest Control - Job
		Reference	PC/ABM/AW00319
		Order number	573730
		Date	07/08/2024 01:00 - 05:00
Billing address	ABM UK World Business Centre 3, Newall Road London Heathrow Airport Hounslow TW6 2TA	Job duration	04:00:00
		Driving duration	00:15:47
		Distance travelled	0 mi

Notes: Bird Proofing Head End Platforms 1-4 (Platform)
Retrieve all dead pigeons from the netting and seal some holes noted in nets around cable trunking.
Photos attached.

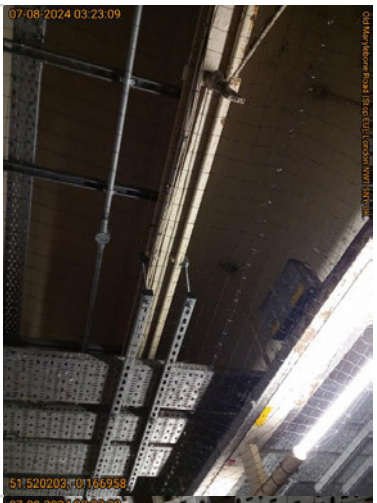
Recommendations (Environmental/ Housekeeping/ Hygiene)	Na
Recommendations (Fabric/ Proofing/ Structural)	Na
Recommendations (Other)	Na
Product Used:	No products used
Quantity (g)/(ml):	0
Post Work Photo 1

Pest Control - Report		
	Answer	**Notes**
Photo 1		
Pest Species Active	No pest found	
Work Report:	A pest control visit has been carried out today. X5 dead PIGEON's have been removed from the netting. Majority of the snagging work was completed which included the twisted net and some damaged netting. It will require another night to start and then complete the netting that starts on platform 2 to 1 and across track. AGS will continue to monitor.
