| Customer | MORDEN LUL STATION (ABM) | Resource | [redacted] |
| | | Reference | PC/ABM/AW00423 |

Notes Proofing of the tunnel walkway

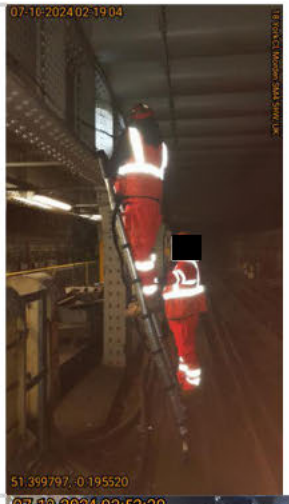
**Photo 3**

| **Pest Species Active** | Feral pigeon (Columba livia) |
| **Level of Activity** | Medium |

| **Work Report:** | Old bird spikes were removed and replaced with new nettings along the right side corners of the structure above the walkway to the depot.<br><br>New bird spikes were also installed in the gaps between the nettings and the structures.<br><br>A total of 12 pigeons were culled today. More culling is required given the high population of the pigeons roosting within the areas. |
